**ASBESTOS INSPECTION AND ASSESSMENT
FOR THE
TRAIN LOAD-OUT FACILITY
MOAB SALT, LLC
MOAB, UTAH**

June 16, 2003

**ASBESTOS ABATEMENT WORK PLAN
FOR THE TRAIN LOAD-OUT FACILITY
MOAB SALT, LLC
MOAB, UTAH**

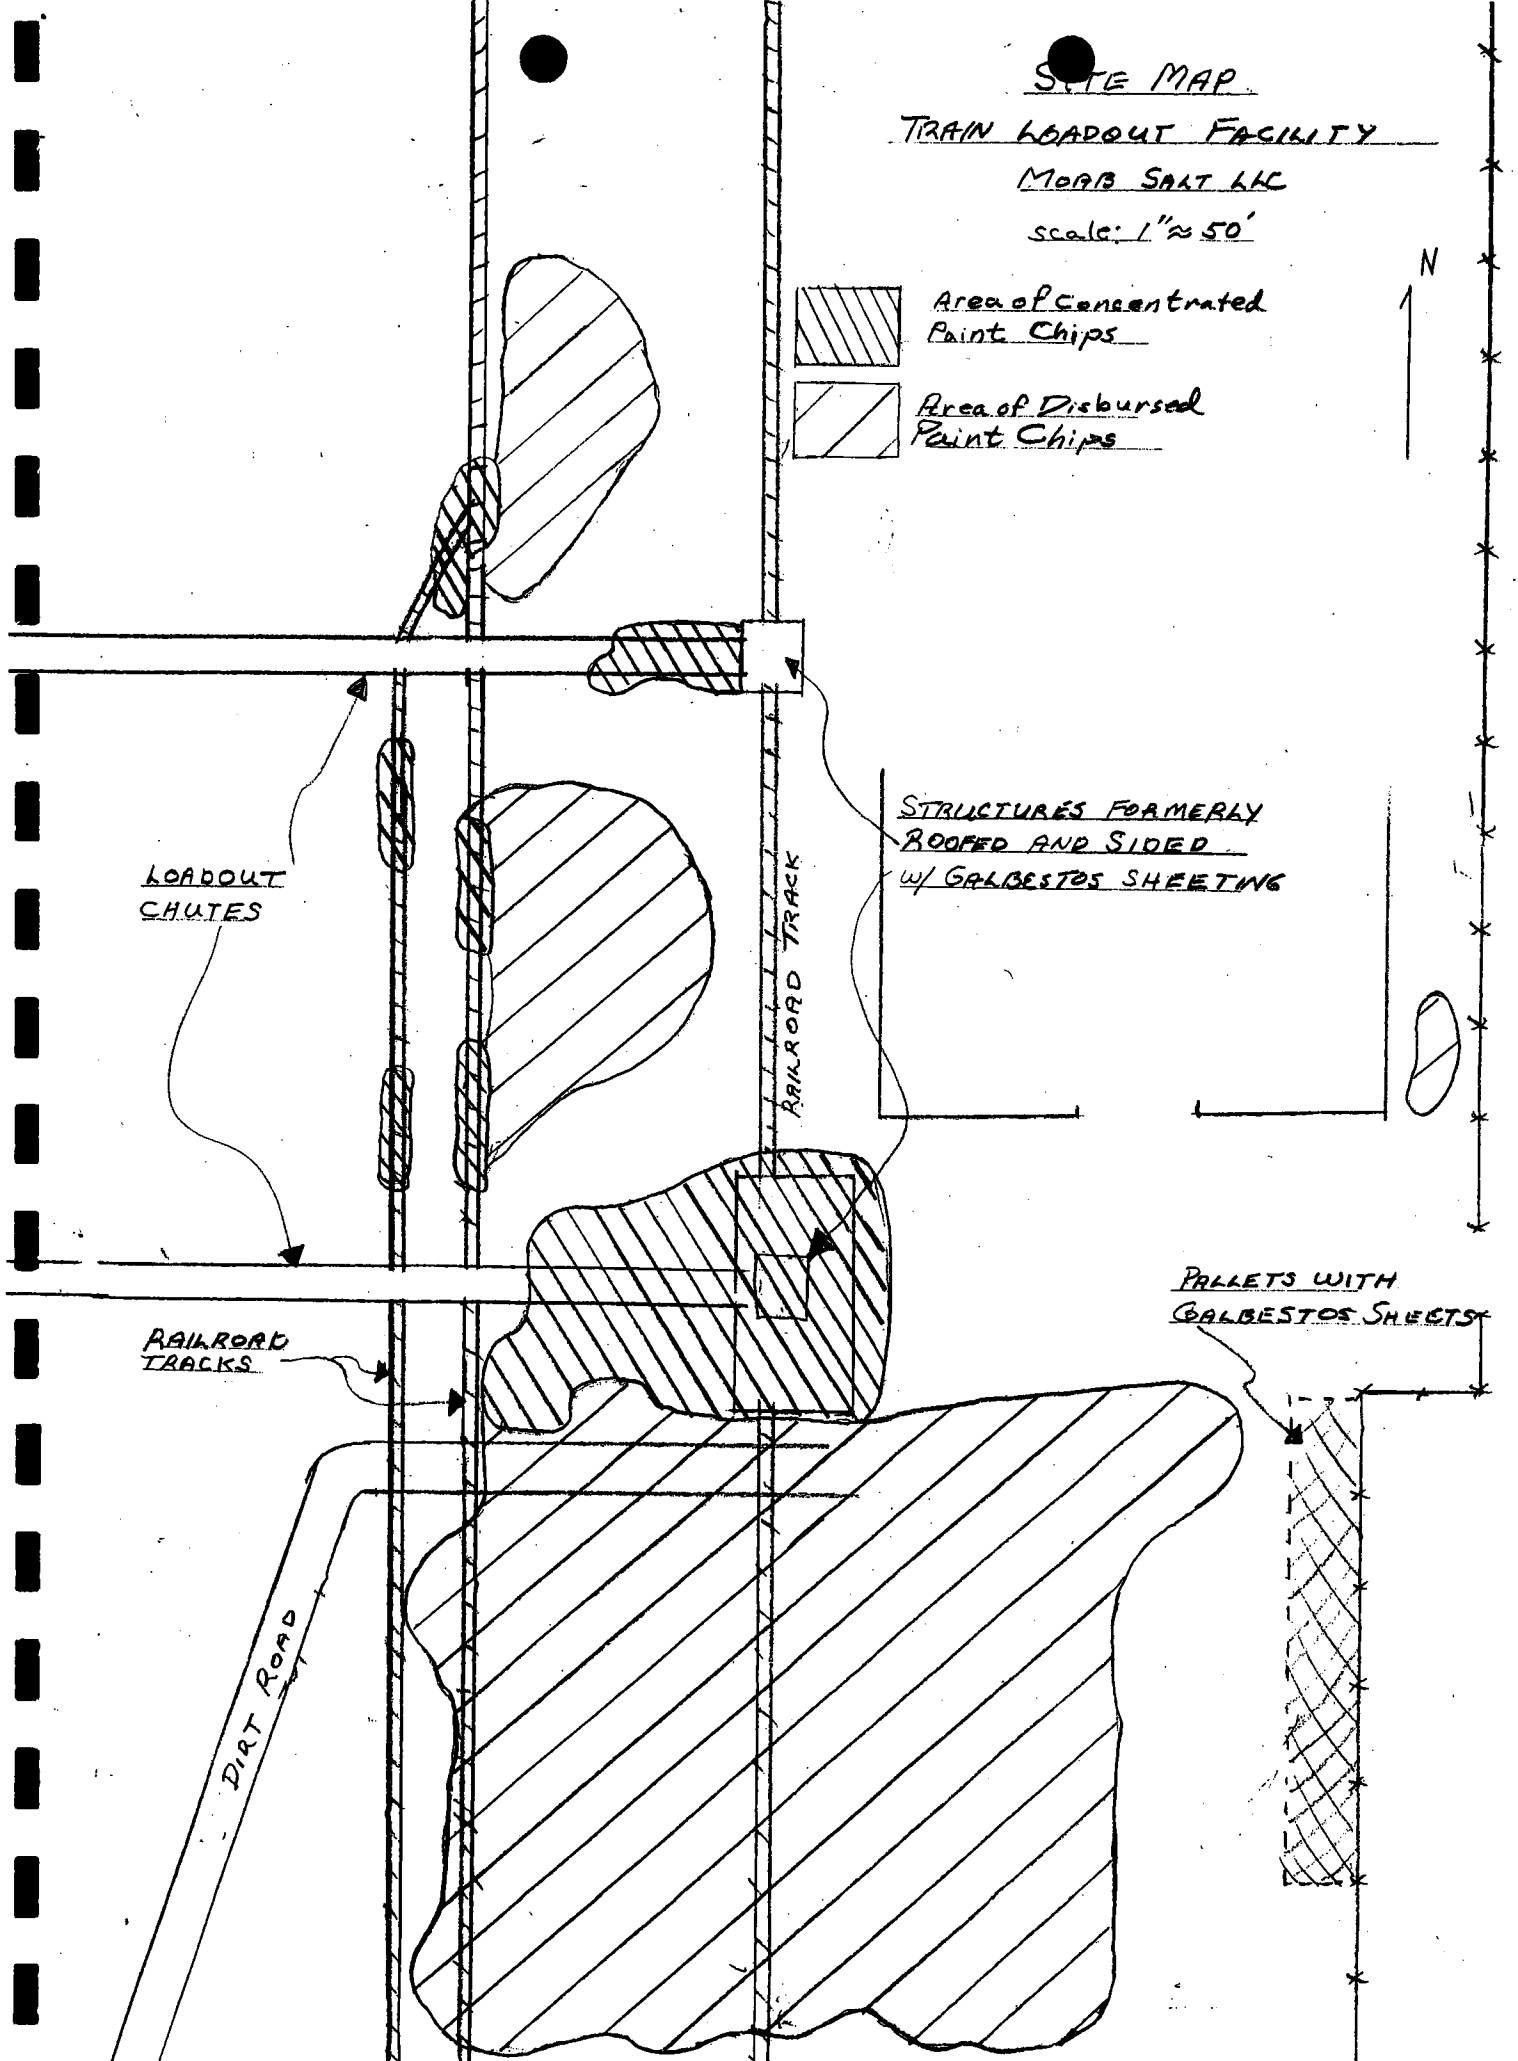
SITE MAP

During this evaluation, JBR determined that the area of surficial soils contaminated by paint chips dislodged during the removal of the Galbestos® sheeting was limited to the areas identified on the site map (Appendix C). Visible paint chips were observed within a defined affected area in the vicinity of the load-out. Paint chips occur as dispersed particles at the outer edges of the affected area and in greater contamination closer to the Train Load-out Facility.

Area of Concentrated
Paint Chips

Area of Disbursed
Paint Chips

The contractor is required to remove all paint chips within the project area defined on the site map (Appendix C). The outer edges of the perimeter can be abated using hand tools. However, for areas that contain a larger amount of paint chips, JBR recommends that a bobcat loader or back-hoe be used to remove all soils to a depth of 2 inches. This will ensure complete abatement of the asbestos materials. All levels within the structure should be abated of any paint chips. During this investigation, JBR observed minimal contamination within the structure.
